## Bozeman National Guard Armory

**24 W MENDENHALL  
BOZEMAN, MT 59715  
MLS# 181074**

*Property Condition Report*

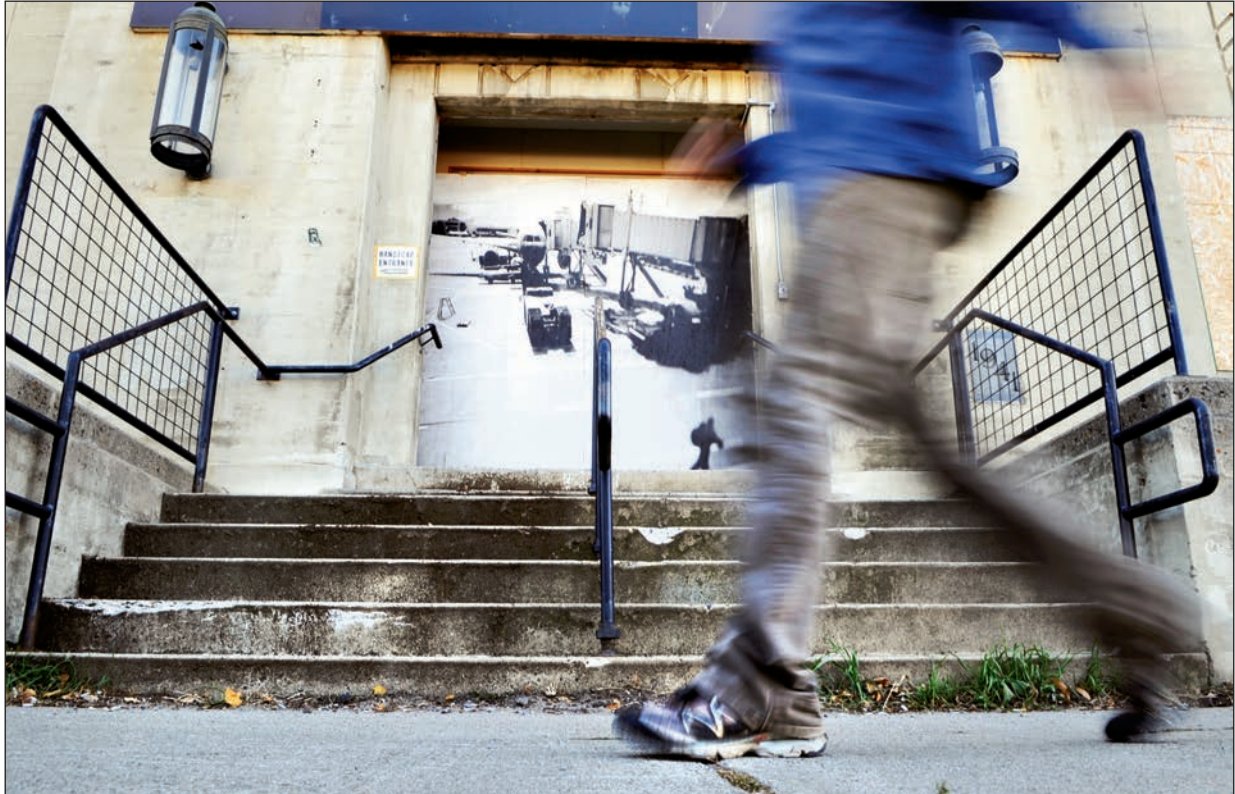
A pedestrian strolls by the Armory building on West Mendenhall Street, Wednesday. Last year, the Armory's former owners gave it back to the mortgage holder, First Interstate Bank of Bozeman, making a deal to avoid foreclosure. Now, the bank is trying to clean it up, ready it for sale, and hopefully find a buyer who will turn it into something the community can be proud of.

But despite its combat-ready construction, the Armory appears defeated. It has sat vacant for five years. The roof leaks. Plywood covers the windows. The structure contains asbestos and lead paint. Last year, the building's former owners gave it back to the mortgage holder, First Interstate Bank of Bozeman, making a deal to avoid foreclosure. Now, the bank is trying to clean it up, ready it for sale, and hopefully find a buyer who will turn it into something the community can be proud of.

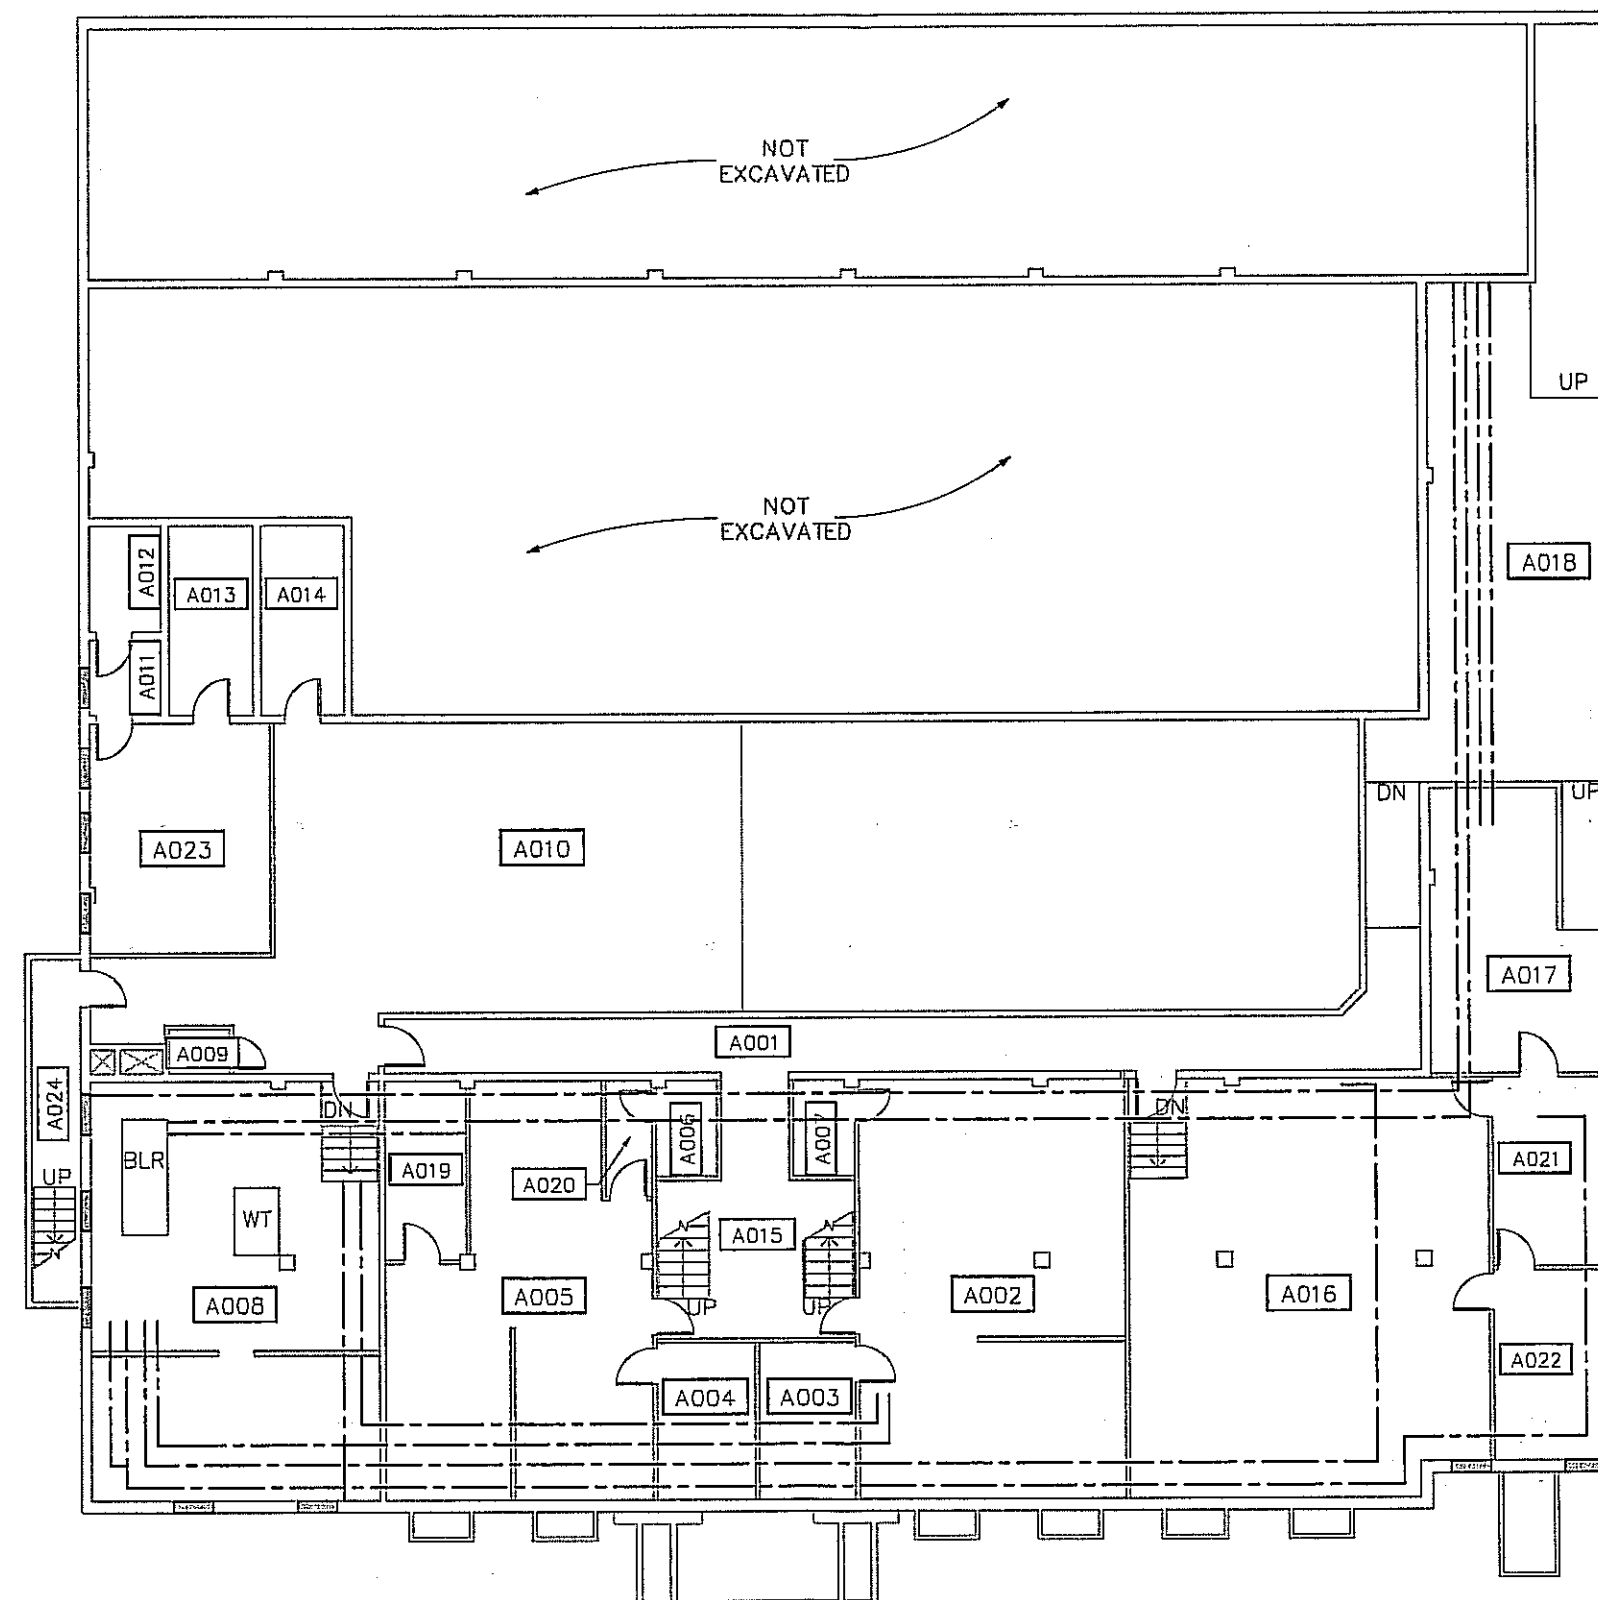
FIG.1: CONFIRMED ACM AND LBP  
HOMOGENEOUS AREA LOCATIONS.  
\*BASEMENT\*

1.) CONFIRMED LEAD BASED PAINT MATERIALS NOT SHOWN INCLUDE:

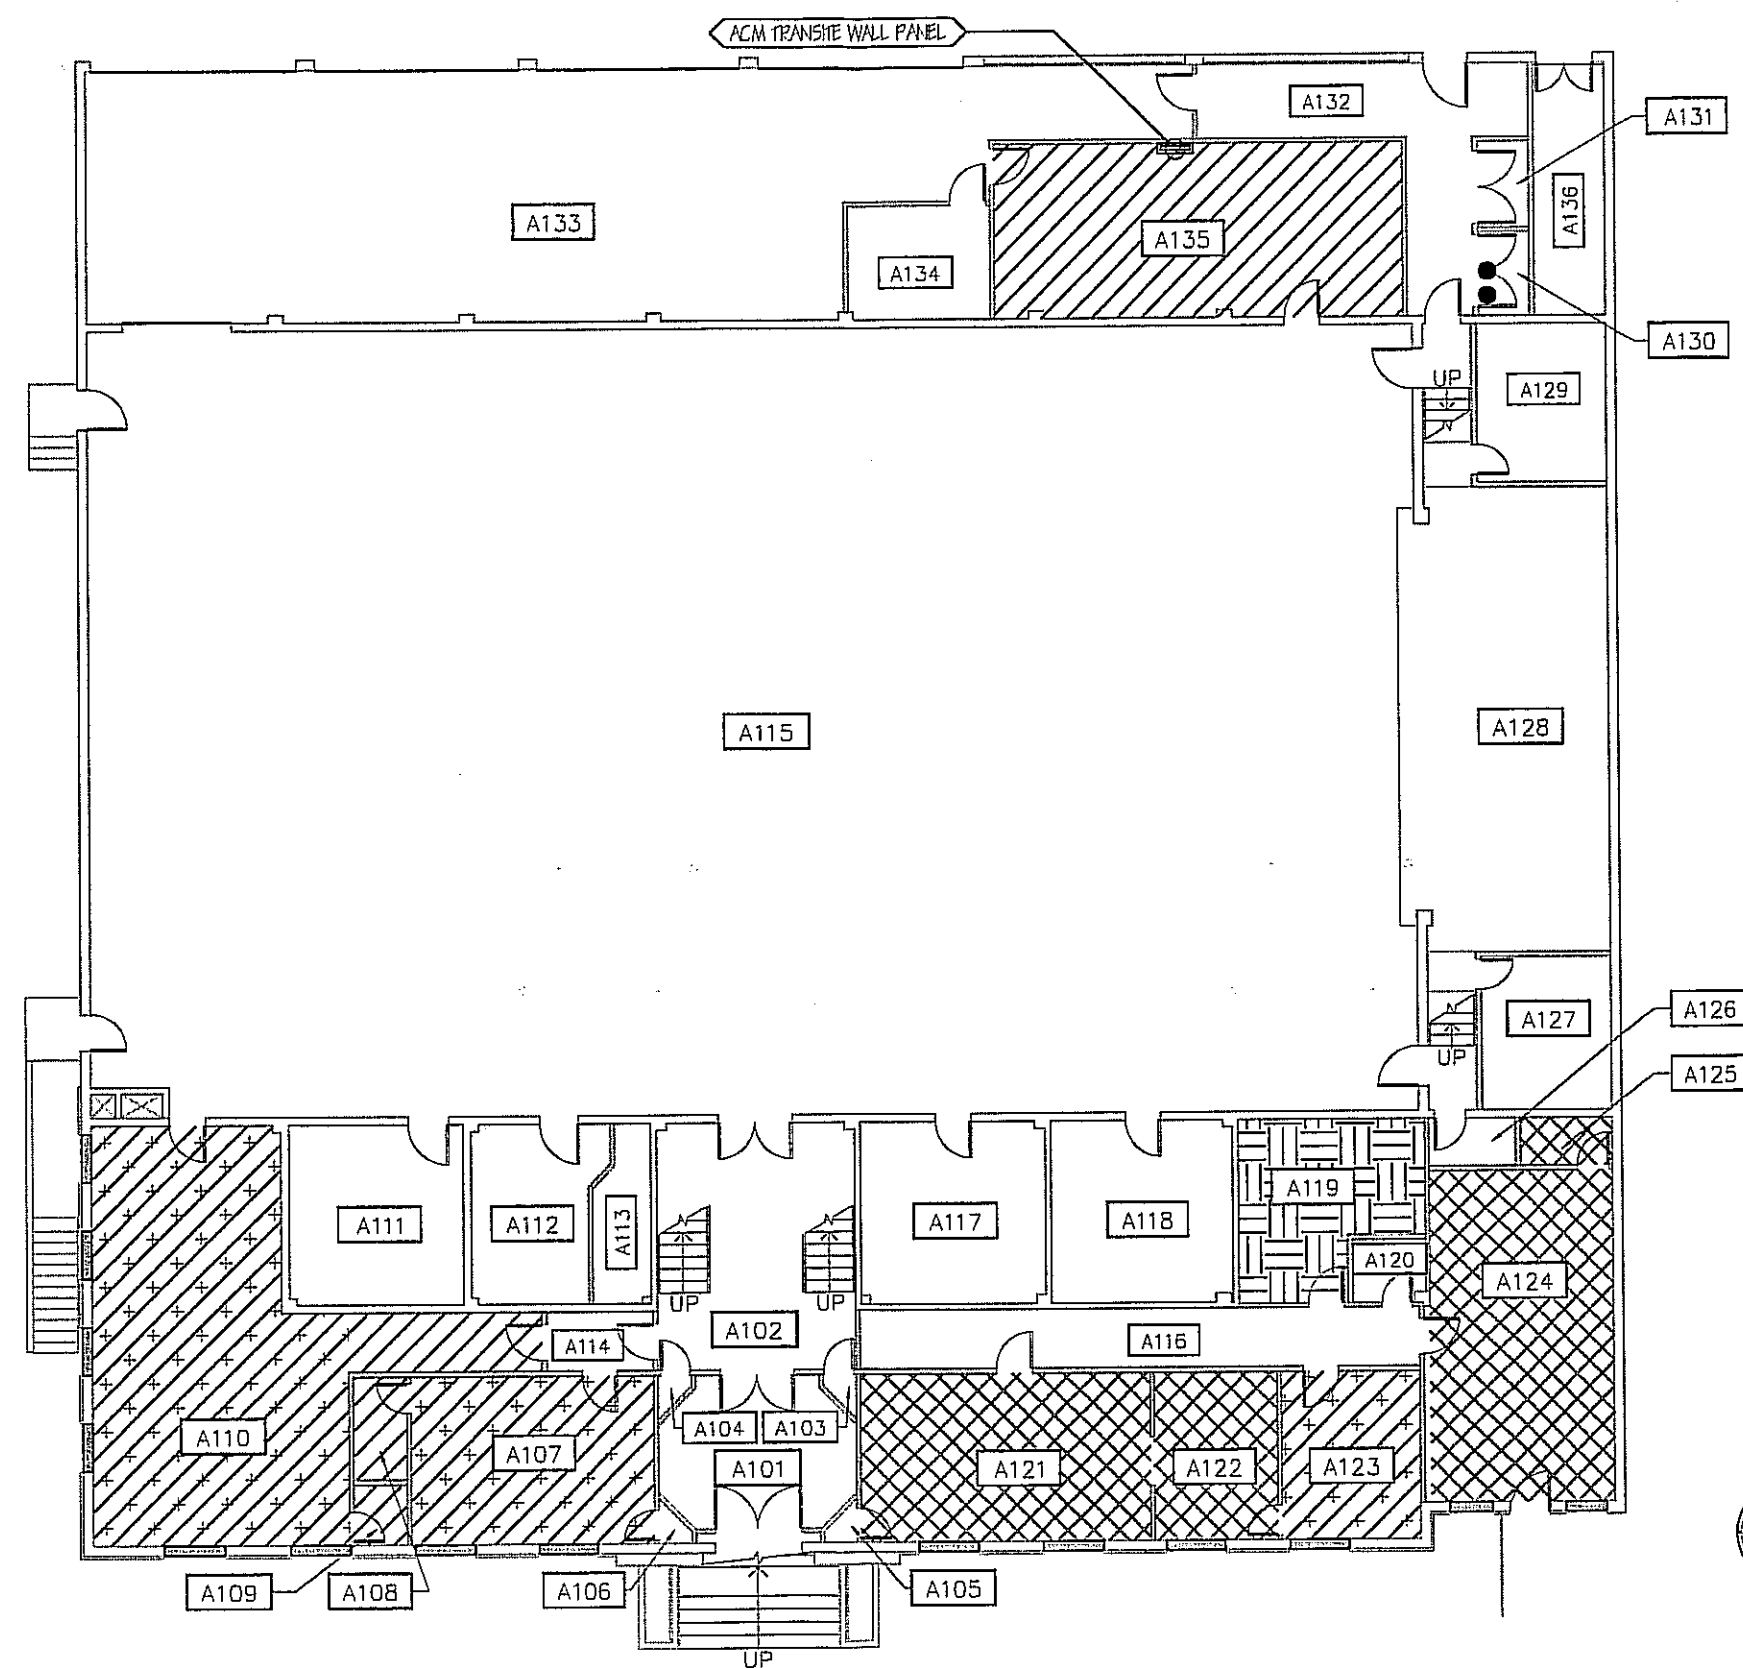
FIG.2: CONFIRMED ACBM AND LBP  
HOMOGENEOUS AREA LOCATIONS.  
\*1ST FLOOR\*

- 1.) CONFIRMED LEAD BASED PAINT MATERIALS NOT SHOWN INCLUDE:  
\*WALL AND CEILING PLASTER.

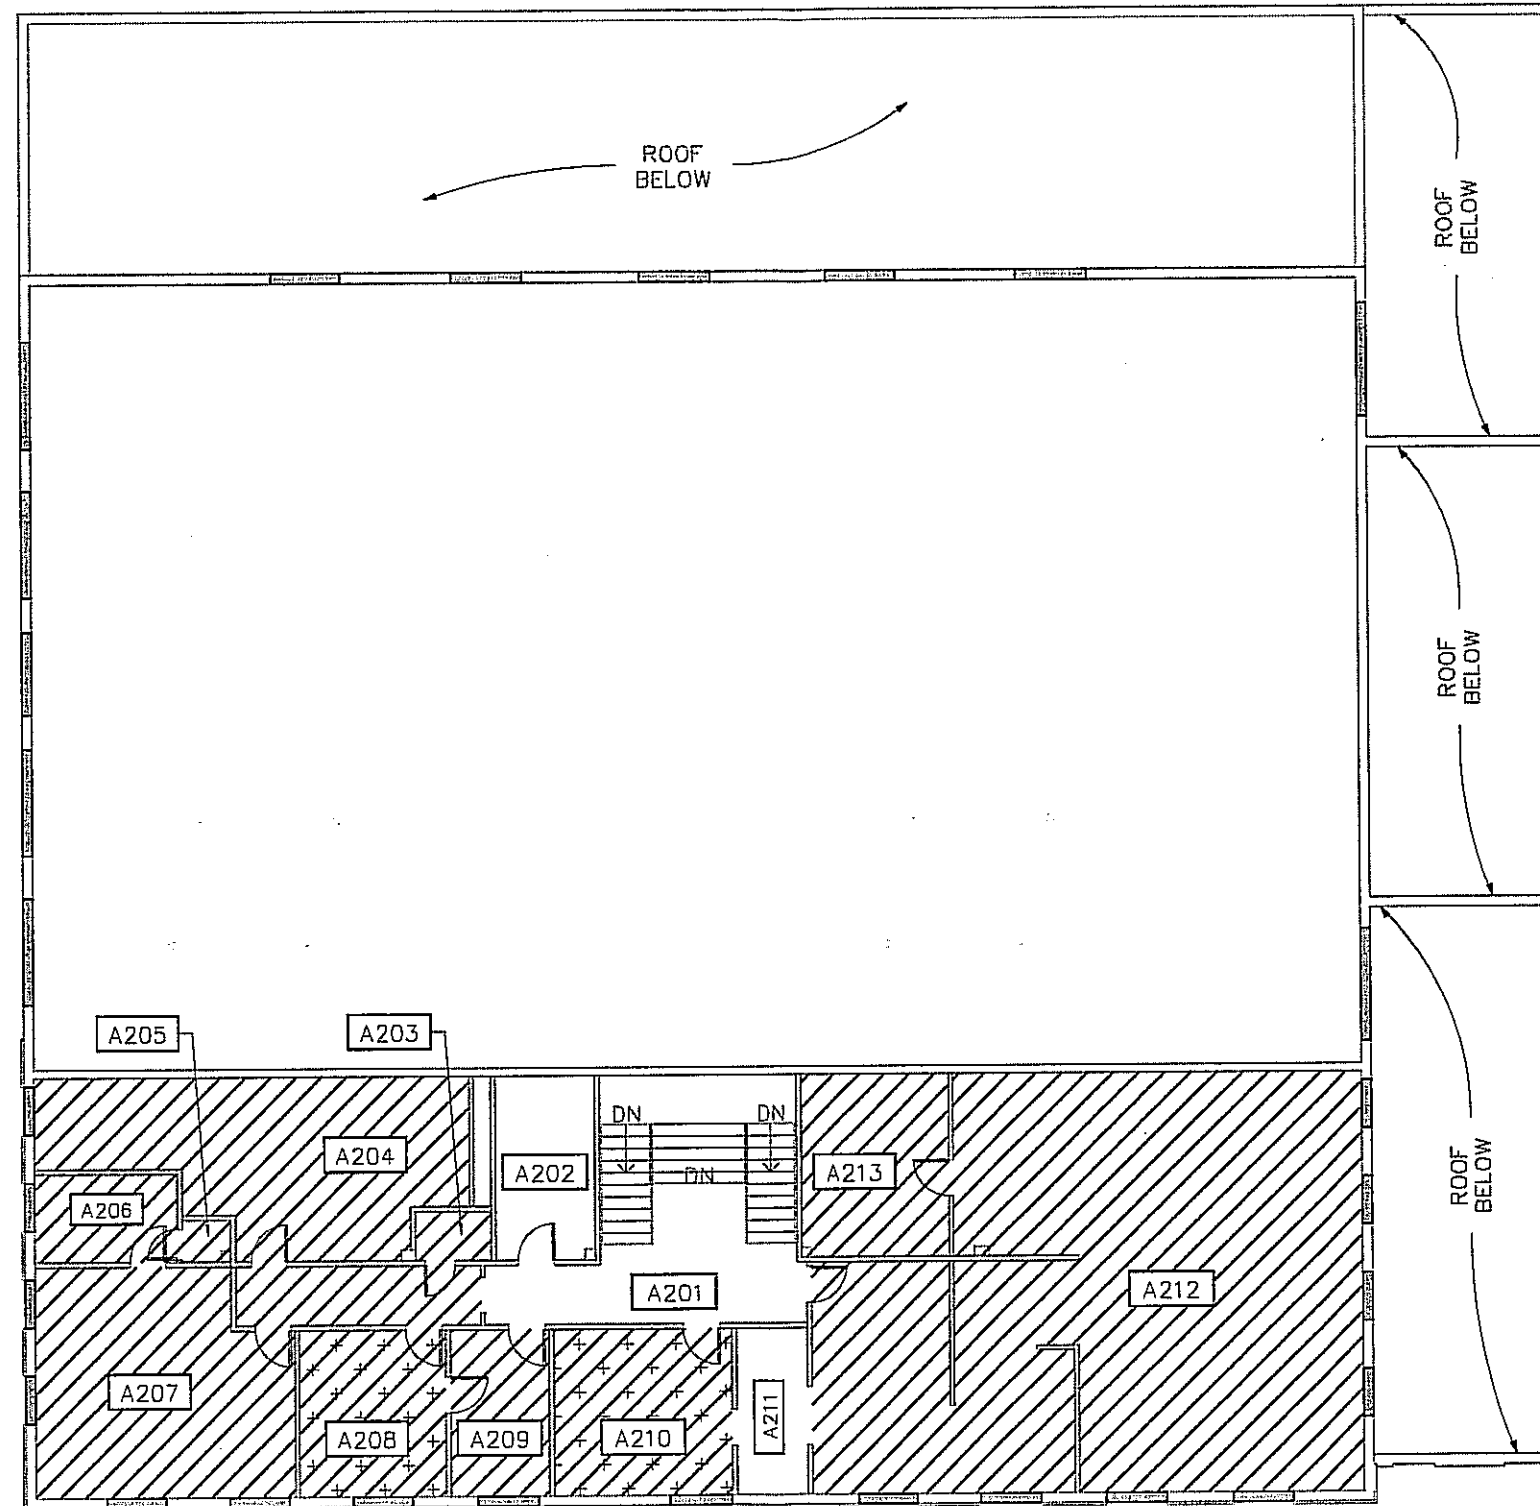
FIG.3: CONFIRMED ACM AND LBP  
HOMOGENEOUS AREA LOCATIONS.  
\*2ND FLOOR\*

1.) CONFIRMED LEAD BASED PAINT MATERIALS NOT SHOWN INCLUDE:

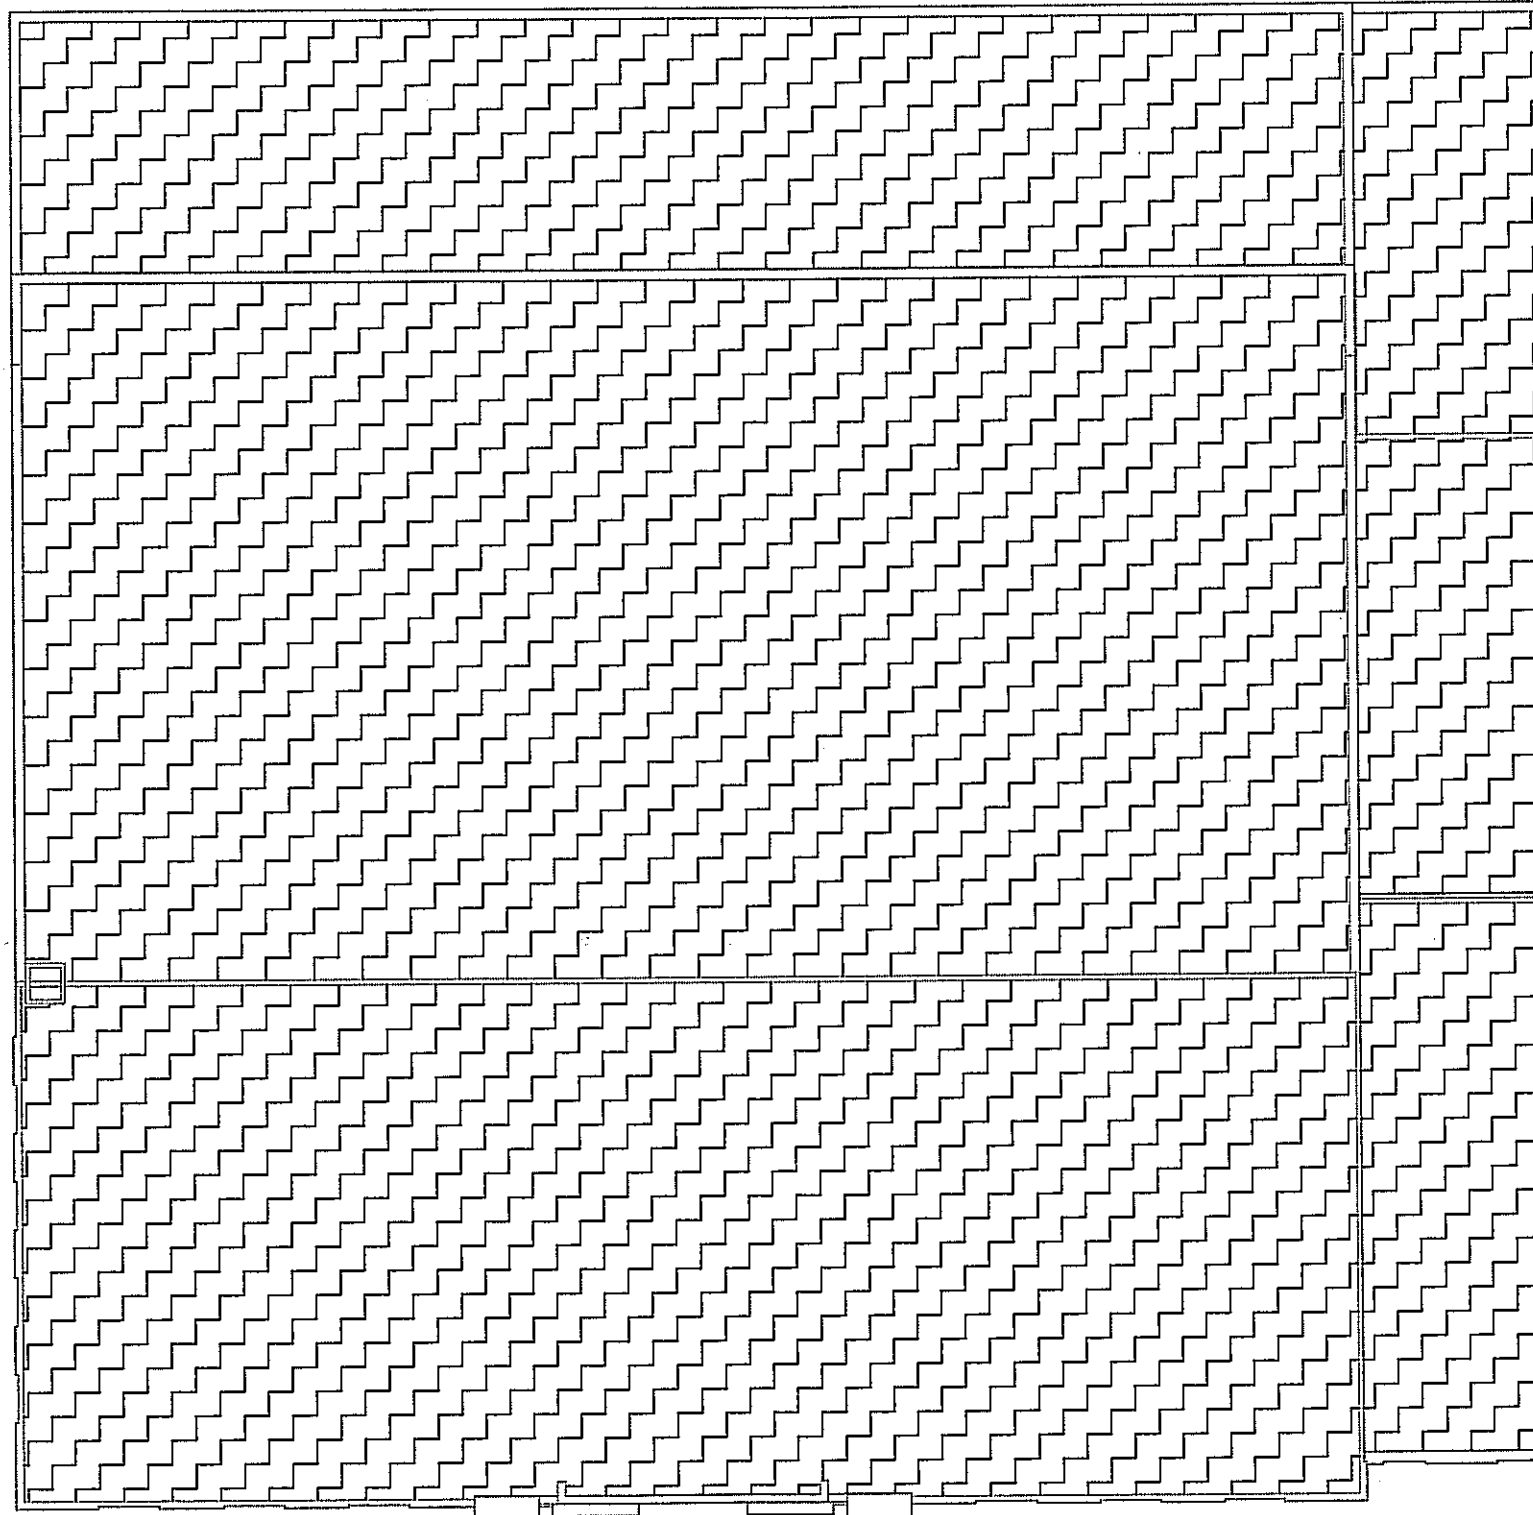
FIG.4: CONFIRMED AND ASSUMED ACBM AND LBP  
HOMOGENOUSE AREA LOCATIONS.  
\*ROOF\*

\*NO LEAD BASED PAINT MATERIALS  
WERE FOUND ON THIS LEVEL.

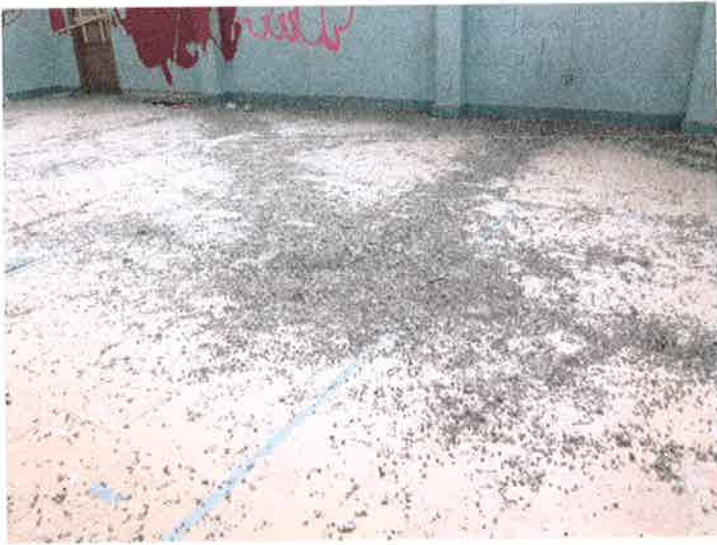
View of bird droppings on drill floor.

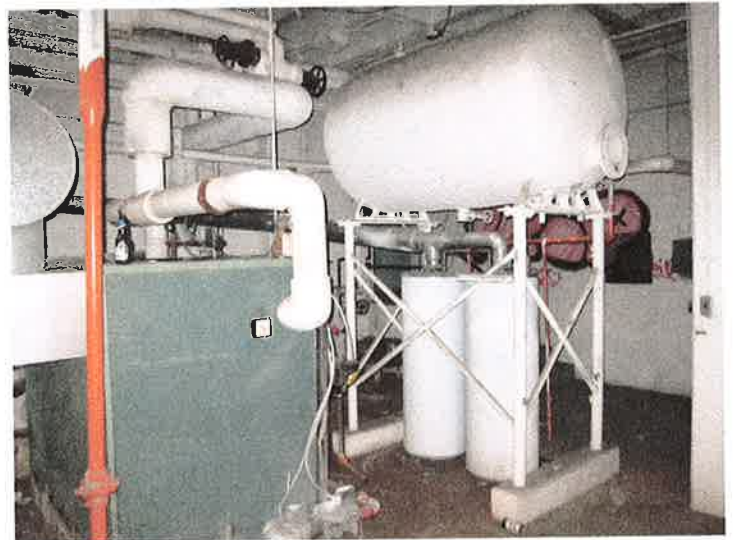
View of boiler room.

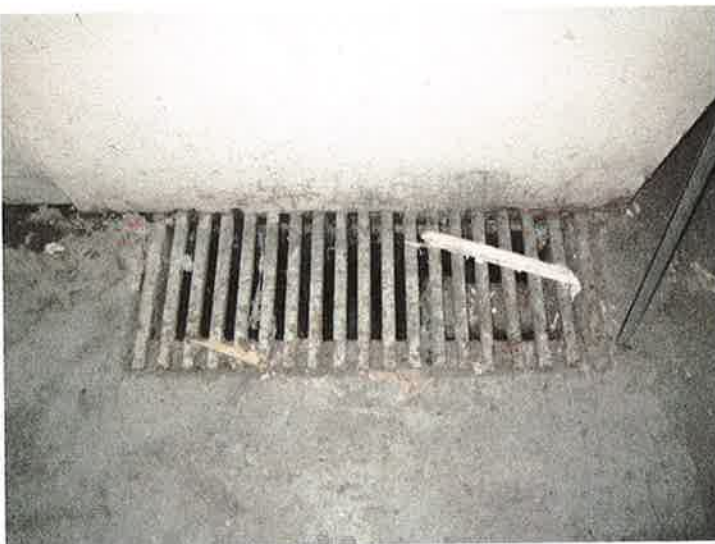
View of floor drain near main floor storage room.

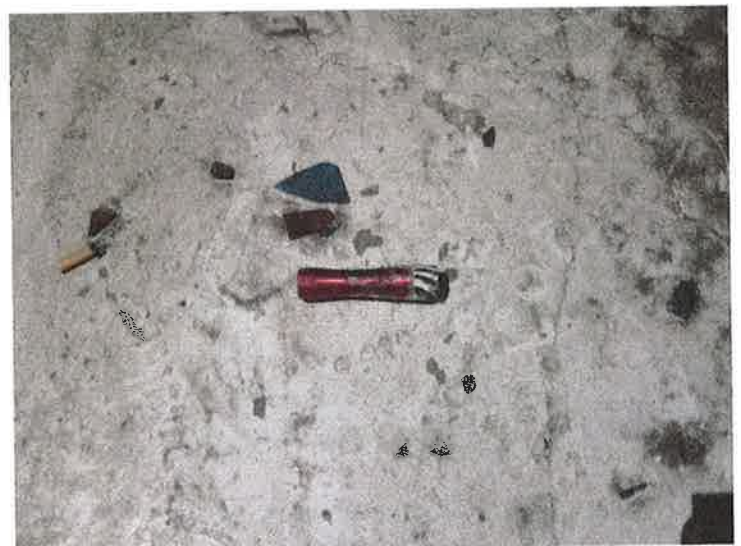
View of drug paraphernalia in basement.

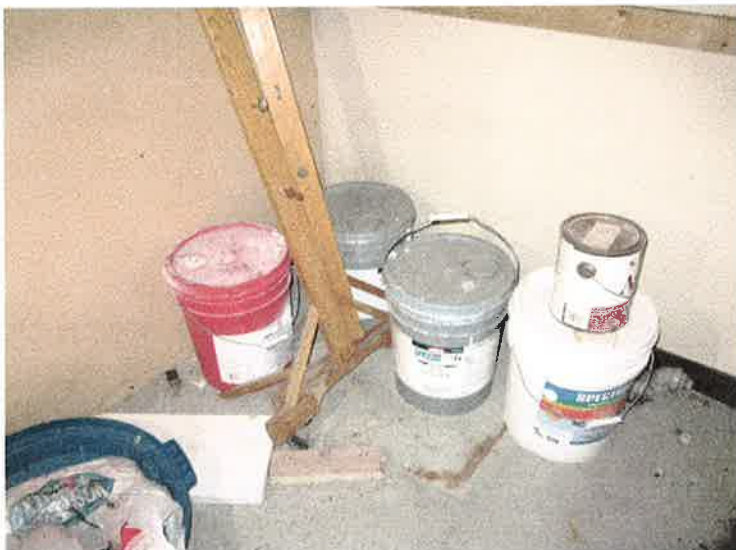
View of second floor paint..

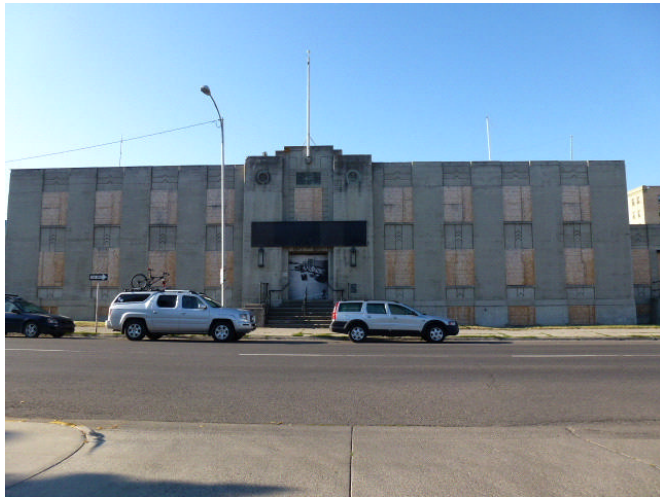
**Photo #1**

North Elevation.

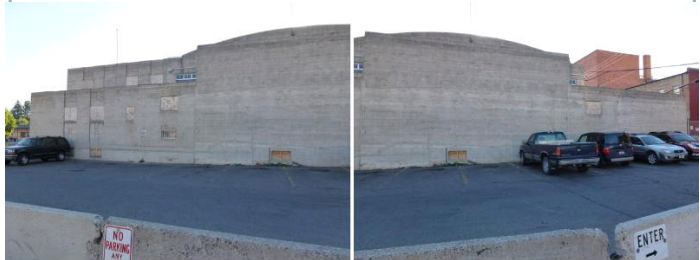
**Photo #2**

West Elevations.

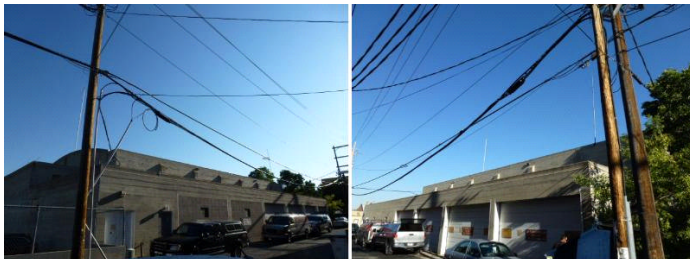
**Photo #3**

South Elevations.

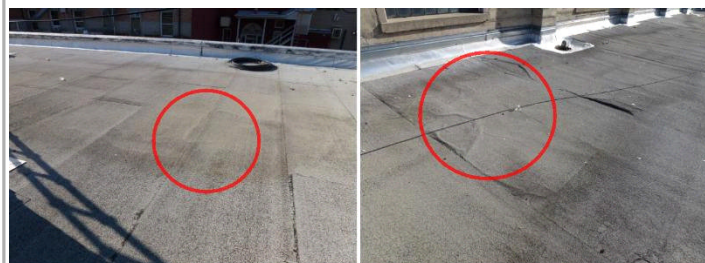
**Photo #9**

Evidence of water ponding was noted at various areas on the flat roof above the south garage. Recommend further evaluation by a Roofer.

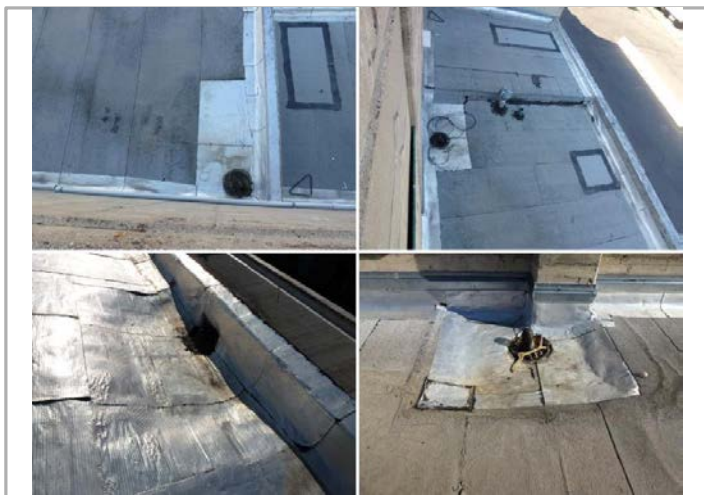
← **Photo #12**

Roof drainage appears to be inadequate at all sides of the roof system. Recommend further evaluation by a Roofer.

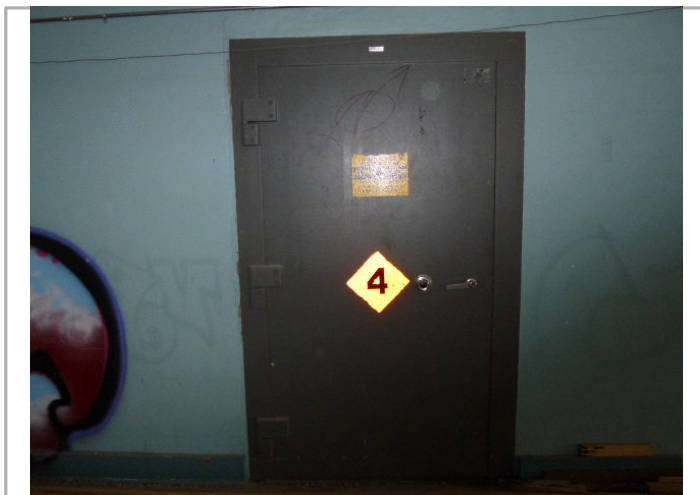
← Photo #15

We were unable to fully evaluate the safe located in the gymnasium due to no access. Recommend further evaluation.

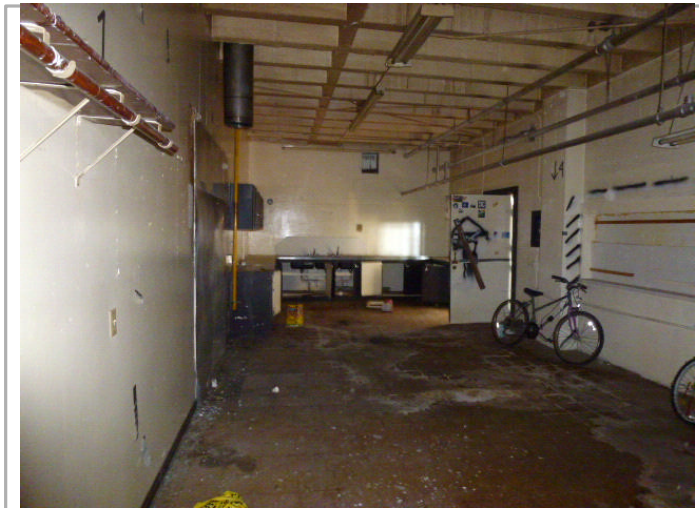
**Photo #17** →

The kitchen on the main level has been stripped of it's appliances.

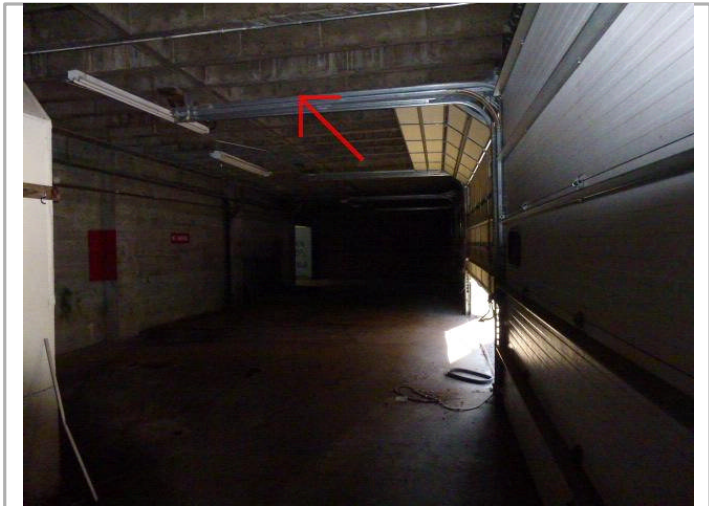
**Photo #20** →

There are numerous area of water intrusion at the ceiling in the garage area.

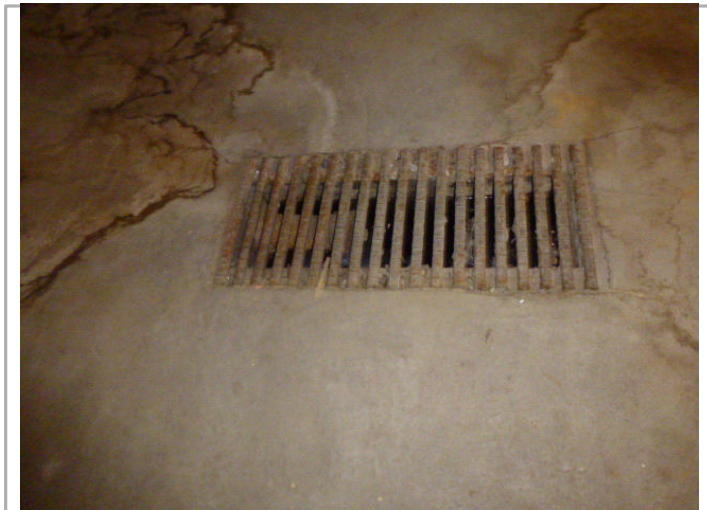
**Photo #23** →

The floor drains in the garage are full of water. Recommend further evaluation by a Licensed Plumber.

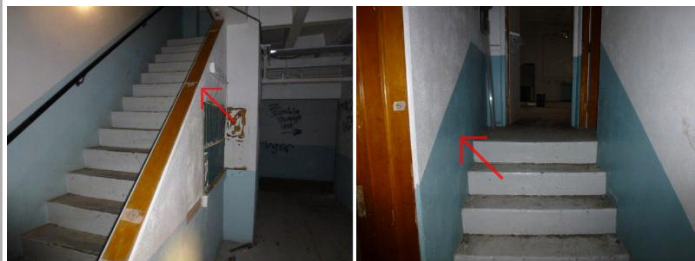
← **Photo #27**

There is no handrail installed at the stairs up to the stage at the north and south ends. The hand rail has been removed at the stairways to the lower level. Recommend the addition of handrails at these locations for safety reasons.

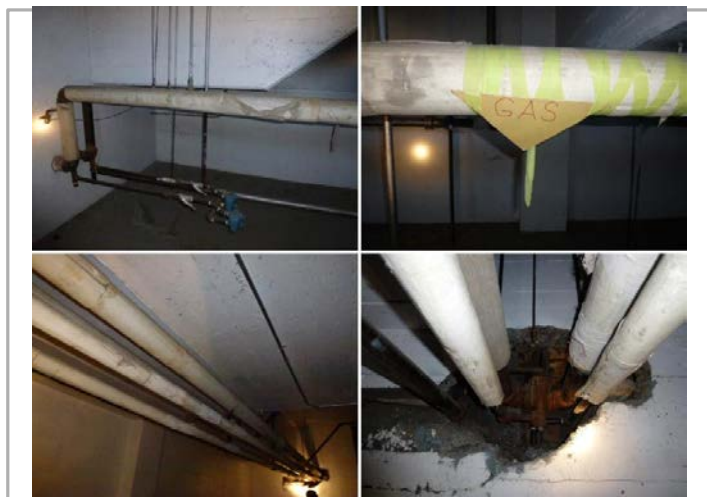
**Photo #30**

There is large amounts of possible ACM (Asbestos Containing Material) insulating the pipes at the west side of the structure in the ramp area to the basement. Recommend further evaluation by a Environmental Engineer.

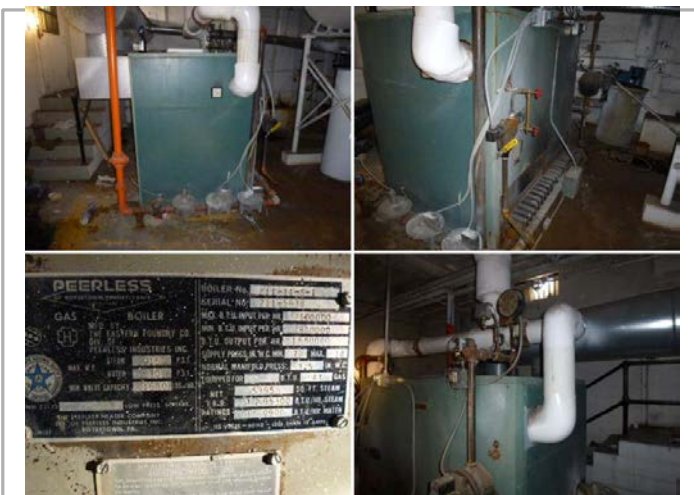
← **Photo #33**

The boiler is located in the mechanical room located at the N.E. corner of the basement. The gas and water was off to this unit on the day of the assessment thus we could not fully evaluate the unit. Recommend further evaluation by Williams Plumbing and Heating.

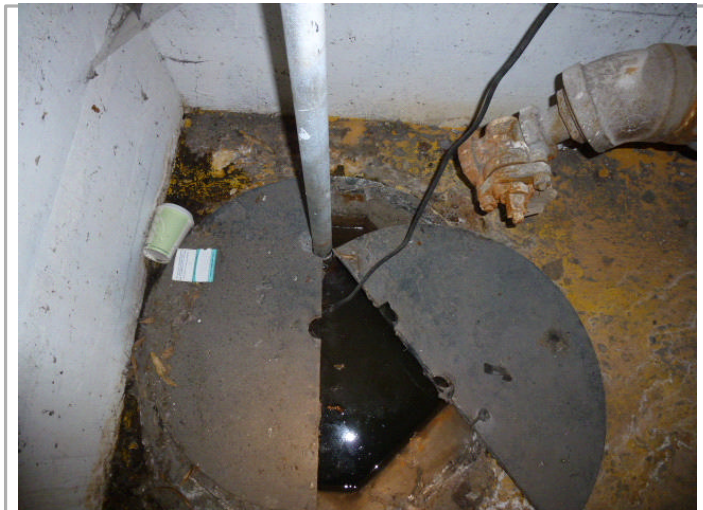
**Photo #35** →

The sump located at the S.E. corner of the mechanical room is full of water. Recommend further evaluation by a Licensed Plumber.

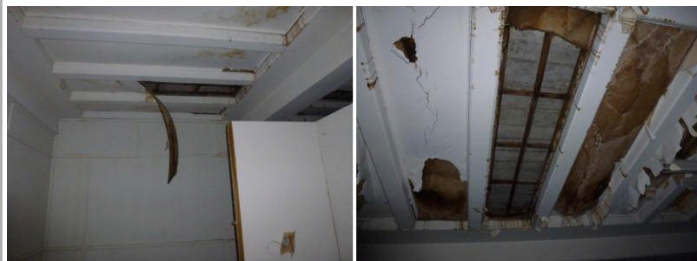
← **Photo #39**

Ceiling damage at the N.W. third floor corner room.

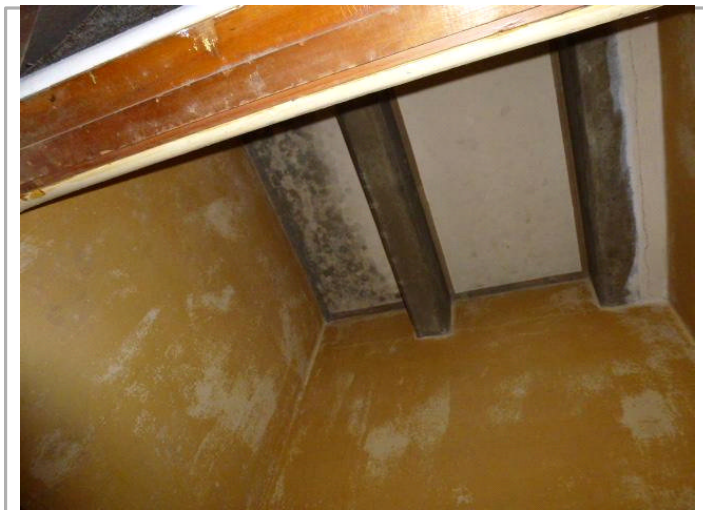
**Photo #41** →

There is a large amount of green fungal matter on the ceiling in the closet in the third level S.E. corner room. Recommend further evaluation by a Environmental Engineer.

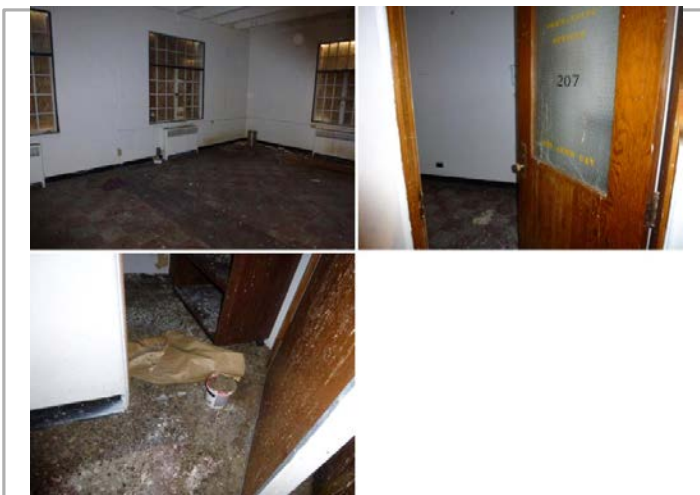
← **Photo #42**

There is a large amount of bird feces on the ceilings, walls and floors in the third floor N.E. corner room.

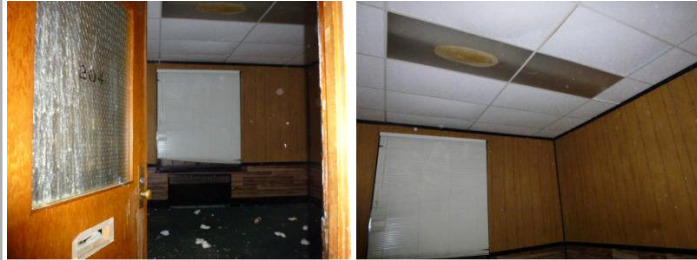
← **Photo #43**

There is moisture damage at the ceilings and floors located in the north office east hallway.
